Final Report

Feasibility Study Gordon Yard Diesel Shop

CANAC carried out a visual inspection of each VIA unit recently and compiled a "condition assessment" sheet supported by photographs.

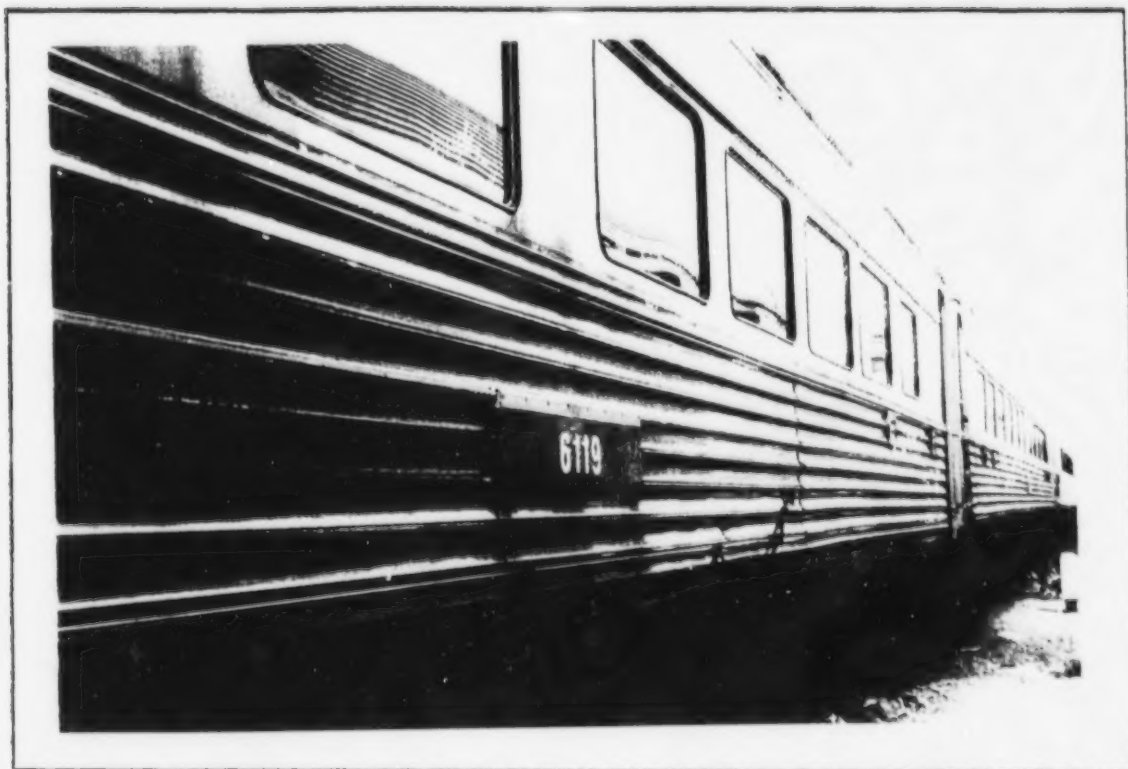
Car Number: **VIA 6119**Type: **RDC1 Snack**Inspected by: **R. BORDUAS**Date: **AUGUST 18, 1999**Location: **TORONTO**Year Built: **1950 - 1957**Mileage: **UNKNOWN**Last Major Shopping: **UNKNOWN**

TRUCKS	SITUATION			CONDITION			REMARKS
	Intact	Cannibalised	Vandalised	Good	Fair	Poor	
4-Wheels I.S.H. Built up	X				X		MILEAGE WEAR (40%).
Wheel Slip Devices	X			X			DECELOSTAT, TO TEST AND SERVICE.
Springs	X			X			
Wheels	X			X			34 IN.. DIAMETER WHEELS, 5½x10 BEARINGS.
AIR BRAKES	SITUATION			CONDITION			REMARKS
	Intact	Cannibalised	Vandalised	Good	Fair	Poor	
D-22, 26L systems	X						
Control Valves	X				X		DUE C.O.T.S.
Reservoirs	X				X		TO FLUSH AND TEST.
Hand Brakes	X				X		DUE PERIODIC TESTS.
HEATING	SITUATION			CONDITION			REMARKS
	Intact	Cannibalised	Vandalised	Good	Fair	Poor	
Engine Coolant							
Floor Heat Coils	X			X			TO TEST AND SERVICE.
Overhead Coils	X			X			TO TEST AND SERVICE.
AIR CONDITIONING	SITUATION			CONDITION			REMARKS
	Intact	Cannibalised	Vandalised	Good	Fair	Poor	
Freon 12 System	X			X			ENVIRONMENT ISSUE, CONSIDER CONVERSION CARRIER SYSTEM.
Condenser	X			X			TO BLOW AND TEST.
Evaporator	X			X			TO WASH AND TEST.

Compressor	X			X			TO BENCH OVERHAUL.
ELECTRIC	SITUATION			CONDITION			REMARKS
	Intact	Cannibalised	Vandalised	Good	Fair	Poor	
110/220 Volts DC	X					X	ORIGINAL WIRING PERISHED.
DC Generator	X			X			2X 10 kw TO BENCH, TEST AND OVERHAUL.
Batteries		X					REMOVED.
Control Panel	X			X			OLD TYPE, TO TEST AND SERVICE.
Lighting			X			X	FIXTURES BROKEN.
Main Blower Fans	X			X			TO BENCH OVERHAUL.

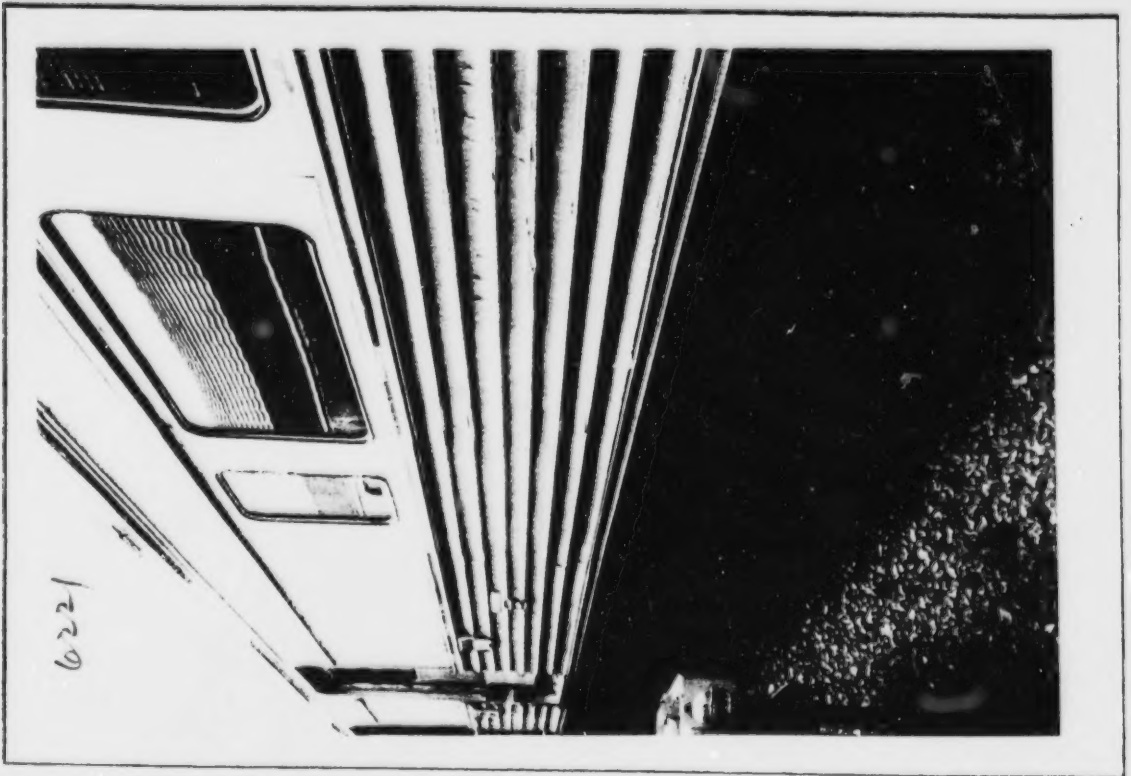
PASSENGER CAR / CONDITION ASSESSMENT

UNDERFRAME	SITUATION			CONDITION			REMARKS
	Intact	Cannibalised	Vandalised	Good	Fair	Poor	
Center Sill	X			X			
Side Sills	X			X			SIDE SILL CAP DENTED - 6 FT, L-SIDE
End Sills	X			X			
Cross Bearers	X			X			
Needle Beams	X			X			
Couplers & Gears	X			X			"F" TYPE WAUGHMAT GEARS.
Buffers / Stems	X			X			
Pilots	X			X			
STRUCTURE	SITUATION			CONDITION			REMARKS
	Intact	Cannibalised	Vandalised	Good	Fair	Poor	
Side Sheating and Posts						X	HORIZONTAL DISTORTION PIER PANELS, FLUTING AND CAPS, A-END.
Roof	X					X	PATCHED, EVIDENCE OF LEAKS.
Vestibule Doors	X				X		
Vestibule Steps	X			X			
Trap Doors	X				X		BENDING.
Diaphragms & Canvas	X				X		CANVAS TORN.
Platform	X			X

TRUCKS	SITUATION			CONDITION			REMARKS
	Intact	Cannibalised	Vandalised	Good	Fair	Poor	
4-Wheels I.S.H.	X				X		MILEAGE WEAR (40%).
Wheel Slip Devices	X			X			DECELOSTAT TO TEST AND SERVICE.
Springs				X			
Wheels				X			34 IN.. DIAMETER WHEELS, 5½x10 BEARINGS.
AIR BRAKES	SITUATION			CONDITION			REMARKS
	Intact	Cannibalised	Vandalised	Good	Fair	Poor	
D-22, 26L systems	X						
Control Valves	X						DUE C.O.T.S.
Reservoirs	X						TO FLUSH AND TEST.
Hand Brakes	X						DUE PERIODIC TESTS.
HEATING	SITUATION			CONDITION			REMARKS
	Intact	Cannibalised	Vandalised	Good	Fair	Poor	
Engine Coolant	X						
Floor Heat Coils	X			X			TO TEST AND SERVICE.
Overhead Coils	X			X			TO TEST AND SERVICE.
AIR CONDITIONING	SITUATION			CONDITION			REMARKS
	Intact	Cannibalised	Vandalised	Good	Fair	Poor	
Freon 12 System				X			ENVIRONMENT ISSUE, CONSIDER CONVERSION FRIGIDAIRE SYSTEM.
Condenser				X			TO BLOW AND TEST.
Evaporator				X			TO WASH AND TEST.

Compressor				X			TO BENCH OVERHAUL.
ELECTRIC	SITUATION			CONDITION			REMARKS
	Intact	Cannibalised	Vandalised	Good	Fair	Poor	
110/220 Volts DC						X	ORIGINAL WIRING.
DC Generator	X			X			2X 10 kw TO BENCH OVERHAUL.
Batteries		X					REMOVED.
Control Panel	X			X			TO TEST AND SERVICE.
Lighting	X			X			TO TEST AND SERVICE.
Main Blower Fans	X			X			TO BENCH OVERHAUL.

ELECTRIC Con't	SITUATION			CONDITION			REMARKS
	Intact	Cannibalised	Vandalised	Good	Fair	Poor	
Exhaust Fans	X			X			TO TEST AND SERVICE.
Refrigeration							N/A
Microwave							N/A
Inverter / Alternator							N/A
Appliances							N/A
WATER SANITATION	SITUATION			CONDITION			REMARKS
	Intact	Cannibalised	Vandalised	Good	Fair	Poor	
Water Tank & Casing	X			X			TO FLUSH TEST AND STERILIZE.
Plumbing	X			X			TO TEST AND SERVICE.
Toilets	X			X			TO TEST AND SERVICE.
Basins	X			X			TO TEST AND SERVICE.
COSMETICS / AMENITIES	SITUATION			CONDITION			REMARKS
	Intact	Cannibalised	Vandalised	Good	Fair	Poor	
Exterior Paint					X		FADED.
Seats	X			X			60 SLEEPY HOLLOW, NO TRAYS.
Upholstery	X				X		DUSTY TO CLEAN.
Carpets	X					X	MILDEWED.
Interior Finish	X				X		
Sashes	X					X	LEAKING.
End Door and Locks	X			X			
Washroom Doors and Locks	X			X			
Window Blinds	X			X

POWER PACKAGE	SITUATION			CONDITION			REMARKS
	Intact	Cannibalised	Vandalised	Good	Fair	Poor	
Engines / Transmission	X				X		2 CUMMINS TO BENCH OVERHAUL.
Engine Pans					X		2 TO R.I.P.
Spicer Shafts					X		TO QUALIFY AND REPAIR.
Air Compressor					X		TO BENCH OVERHAUL.
Fuel Tank	X			X			TO FLUSH AND SERVICE.
Exhaust System	X			X			
Brake Control Valves	X			X			DUE PERIODIC MAINTENANCE.
Event Recorder	X			X			TO TEST AND SERVICE.
Bells / Horns	X			X			TO TEST AND SERVICE.
Radiator	X			X			EVIDENCE OF ANTIFREEZE LEAKS.

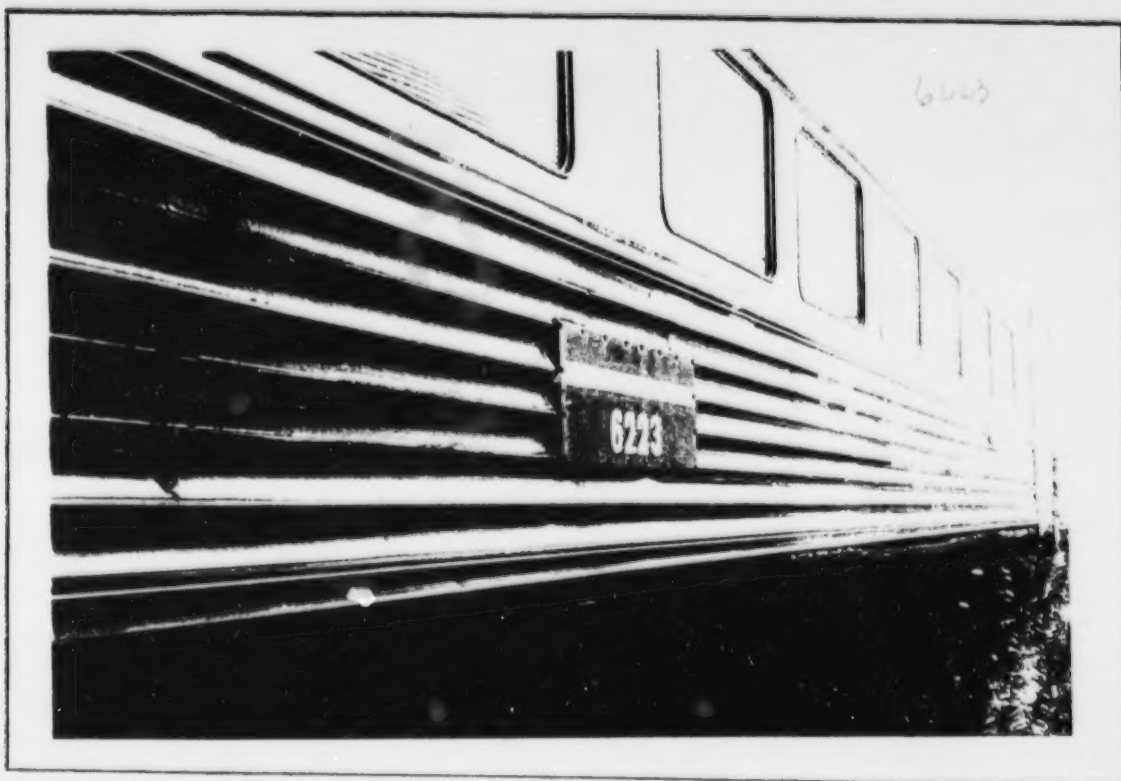
PASSENGER CAR / CONDITION ASSESSMENT

UNDERFRAME	SITUATION			CONDITION			REMARKS
	Intact	Cannibalised	Vandalised	Good	Fair	Poor	
Center Sill				X			
Side Sills						X	SAGGING, NEGATIVE CAMBER.
End Sills				X			
Cross Bearers				X			
Needle Beams				X			
Couplers & Gears				X			"F" TYPE RUBBER GEARS.
Buffers / Stems				X			
Pilots				X			
STRUCTURE	SITUATION			CONDITION			REMARKS
	Intact	Cannibalised	Vandalised	Good	Fair	Poor	
Side Sheating and Posts	X					X	LETTER BOARDS, PIER PANEL, FLUTING AND CAPS HORIZONTAL DISTORTIONS AND POOR JOINTS.
Roof	X					X	LEAKING THROUGHOUT CAR.
Vestibule Doors	X				X		BINDING TO ADJUST.
Vestibule Steps	X				X		LOOSE TREADS (RUBBER).
Trap Doors	X					X	BINDING, TWISTED.
Diaphragms & Canvas	X				X		MISSING A-END. CANVAS TORN B-END.
Platform	X				X		RUBBER LOOSE PERISHED.

TRUCKS	SITUATION			CONDITION			REMARKS
	Intact	Cannibalised	Vandalised	Good	Fair	Poor	
4-Wheels I.S.H. Built up	X					X	HIGH MILEAGE WEAR.
Wheel Slip Devices	X			X			DECELOSTAT, TO TEST AND SERVICE.
Springs	X			X			
Wheels	X			X			34 IN.. DIAMETER WHEELS, 5½x10 BEARINGS.
AIR BRAKES	SITUATION			CONDITION			REMARKS
	Intact	Cannibalised	Vandalised	Good	Fair	Poor	
D-22, 26L systems	X						
Control Valves	X				X		DUE C.O.T.S.
Reservoirs	X				X		TO FLUSH AND TEST.
Hand Brakes	X				X		DUE PERIODIC MAINTENANCE.
HEATING	SITUATION			CONDITION			REMARKS
	Intact	Cannibalised	Vandalised	Good	Fair	Poor	
Engine Coolant							
Floor Heat Coils	X			X			TO TEST AND SERVICE.
Overhead Coils	X			X			TO TEST AND SERVICE.
AIR CONDITIONING	SITUATION			CONDITION			REMARKS
	Intact	Cannibalised	Vandalised	Good	Fair	Poor	
Freon 12 System	X						ENVIRONMENT ISSUE, CONSIDER CONVERSION FRIGIDAIRE SYSTEM.
Condenser				X			TO CLEAN AND SERVICE.
